CONNECTICUT RIVER BASIN  
GLASTONBURY, CONNECTICUT

# ADDISON POND DAM CT 00245

## PHASE I INSPECTION REPORT NATIONAL DAM INSPECTION PROGRAM

APRIL 1981

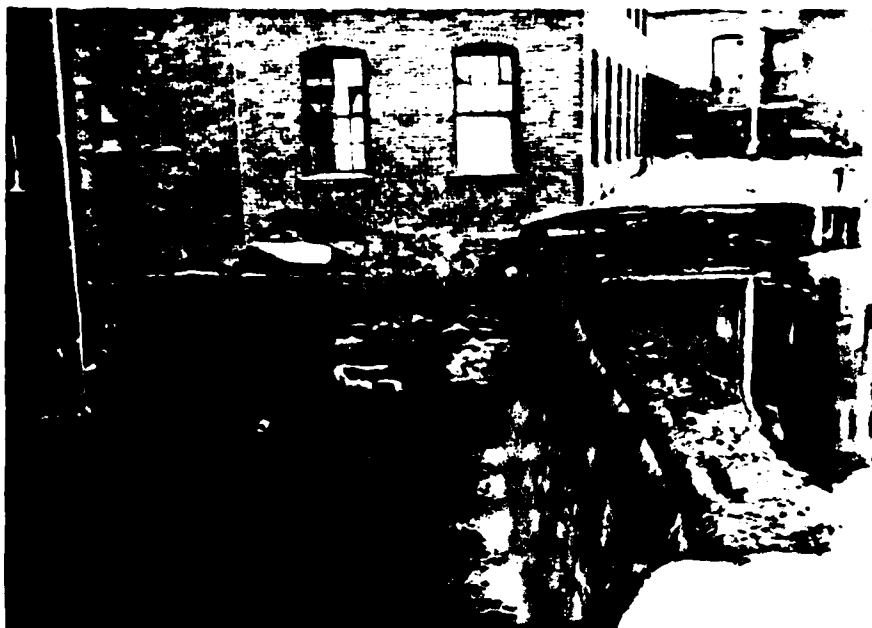
east wall is lacking several stones and its concrete coping, whereas, the west wall is only missing the concrete coping (See Photo 2). Overall, the general condition of the two training walls was good with no evidence of missing mortar or seepage. The approach channel through the training walls and the channel immediately downstream of the spillway was clean with no accumulation of debris (See Photos 3 and 4).

In addition to the regulating outlet, there is a screen covered intake chamber adjacent to the 15' training wall. This structure at one time provided water for several large boilers located in the warehouse. As viewed from the basement, several pipes ranging from 1" to 12" entered the building coming from the direction of the intake chamber. Water was observed to be leaking

from the stone masonry foundation, through the east face of the building into the downstream channel (See Photo 2). The leakage may have been associated with the intake chamber.

Seepage was also observed flowing from the stone masonry foundation of the warehouse located downstream and west of the spillway. The water leaking between the stones is gradually eroding the mortar which increases the possibility of failure of the foundation. Since the west side of the spillway is attached directly to this structure, failure of the building could

possibly result in dam failure. The source of the water may possibly be the intake chamber situated upstream and west of the spillway. Several pipes ranging from 1" to 12" enter the basement coming from the direction of the chamber. It is quite possible that water is leaking from the intake riser into the basement area and subsequently leaking through the foundation wall. This intake chamber should be filled in and sealed off to prevent water from entering the basement.

The 3 1/2' x 4' regulating outlet and its control mechanism which was constructed in the 1950's is presently inoperative. Indirectly, the inoperative state of the outlet decreases the dam stability since the necessary repairs to the dam cannot be accomplished without lowering the pond water level.

Photo 2 - View across spillway. Note  
inoperative outlet works on  
right. Note seepage through  
the wall of the building.

Inspect the dam after the pond has been lowered and investigate the source of leakage through the dam, spillway, and warehouse foundation adjacent to the west side of the spillway;

Design necessary repairs to the dam structures, including the dam, spillway and regulating outlet mechanism.

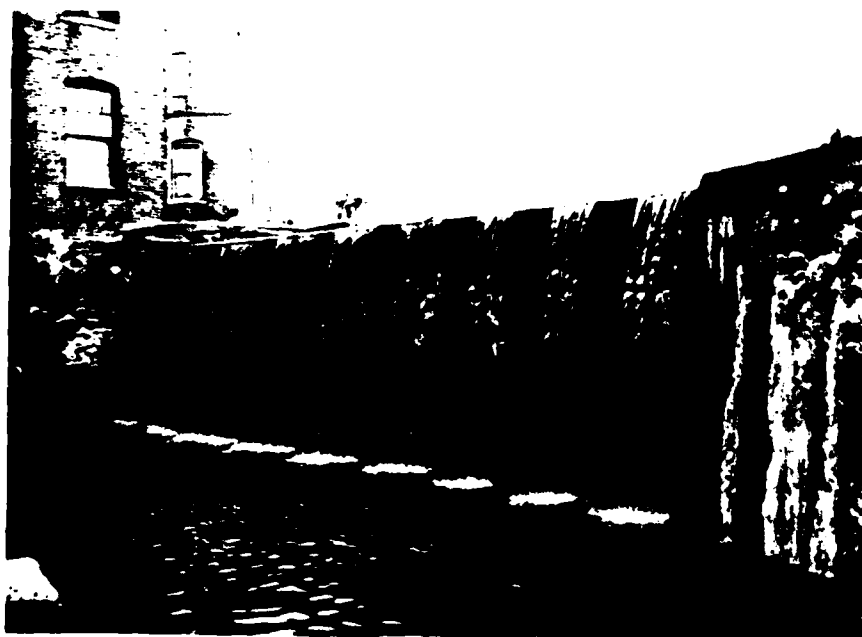
The 50 ft. spillway is a stone masonry structure with a 2 ft. wide concrete coping across the crest (See Photos 2, 3 and 4). Observation revealed leakage all along the spillway between the concrete coping and stone masonry. Due to water flowing over the spillway, a thorough inspection of its face could not be completed.

Photo 4 - View of spillway face.

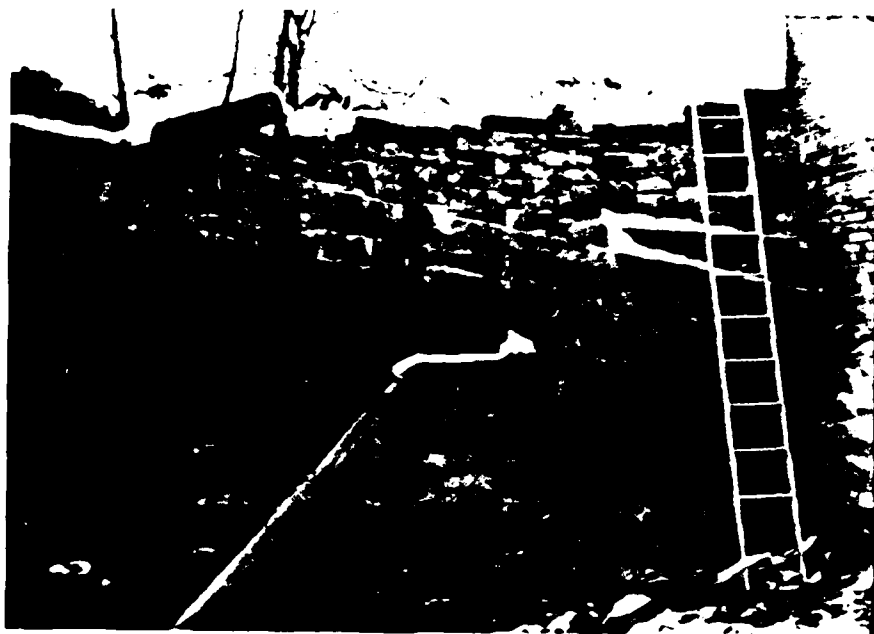
Founded on rock base, the 23' stone masonry east dam embankment was generally in fair condition with an appreciable amount of mortar missing between the stones of the lower two feet.

As shown in Photo 6, minor seepage was observed at these mortarless joints and at the contact zone with the rock base. The upper dam section appeared to be in better condition with the exception of the irregular horizontal alignment as a result of several missing stones (See Photos 5 & 6).

Mortar was missing and seepage was observed between the stones at certain areas of the east dam embankment. The continued deterioration of mortar resulting from the seepage will weaken the stone masonry embankment, increasing the possibility of dam failure. At the first five foot length of dam adjacent to the 50 ft. spillway towards the east, water was leaking between the concrete coping and stone masonry which tends to accelerate deterioration of the mortar by flowing down the face of the dam embankment.

Photo 6 - Seepage zone at contact of bedrock and masonry (Left of ladder).  
Note lack of mortar in joints.

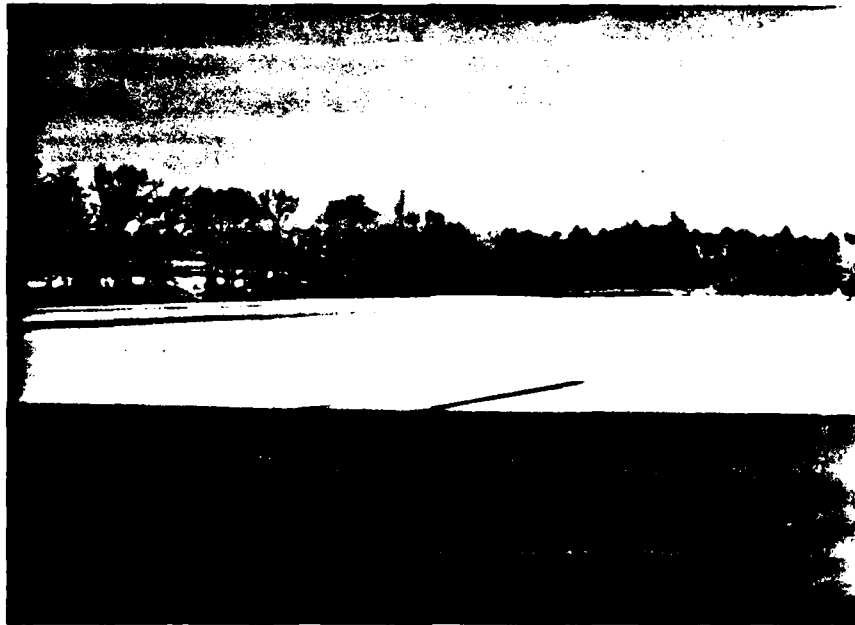
Photo 7 - View of pond from the dam.

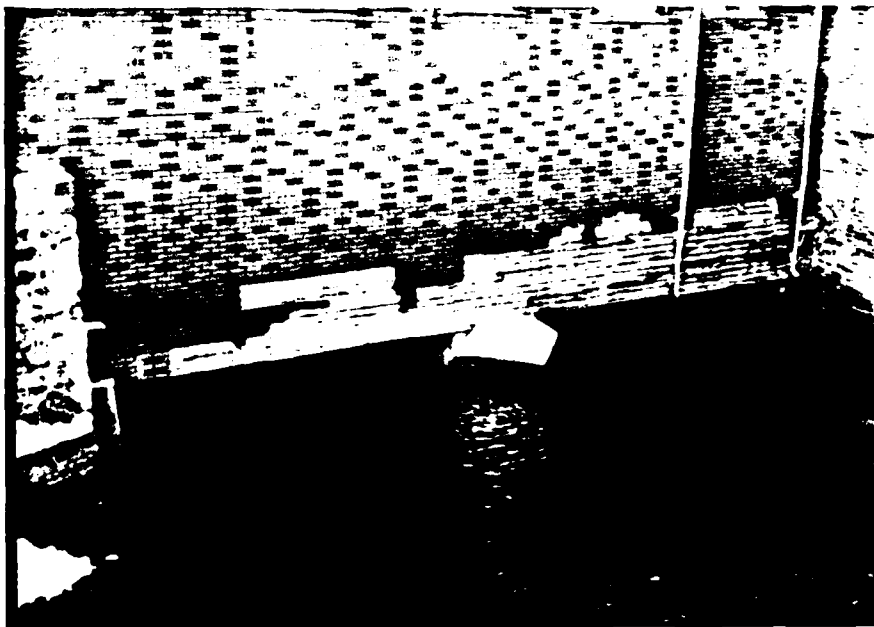
The downstream channel immediately south of the spillway flows under Porch and Patio warehouse, which is supported by timber girders on concrete pedestals. During the inspection of the downstream channel, one pedestal was observed to be displaced and not carrying the girder.

Photo 8 - Channel under warehouse downstream of spillway.
